**WIGGINS OZARK CAMP DAM**

**REYNOLDS COUNTY, MISSOURI**

**MO 30026**

**PHASE 1 INSPECTION REPORT  
NATIONAL DAM SAFETY PROGRAM**

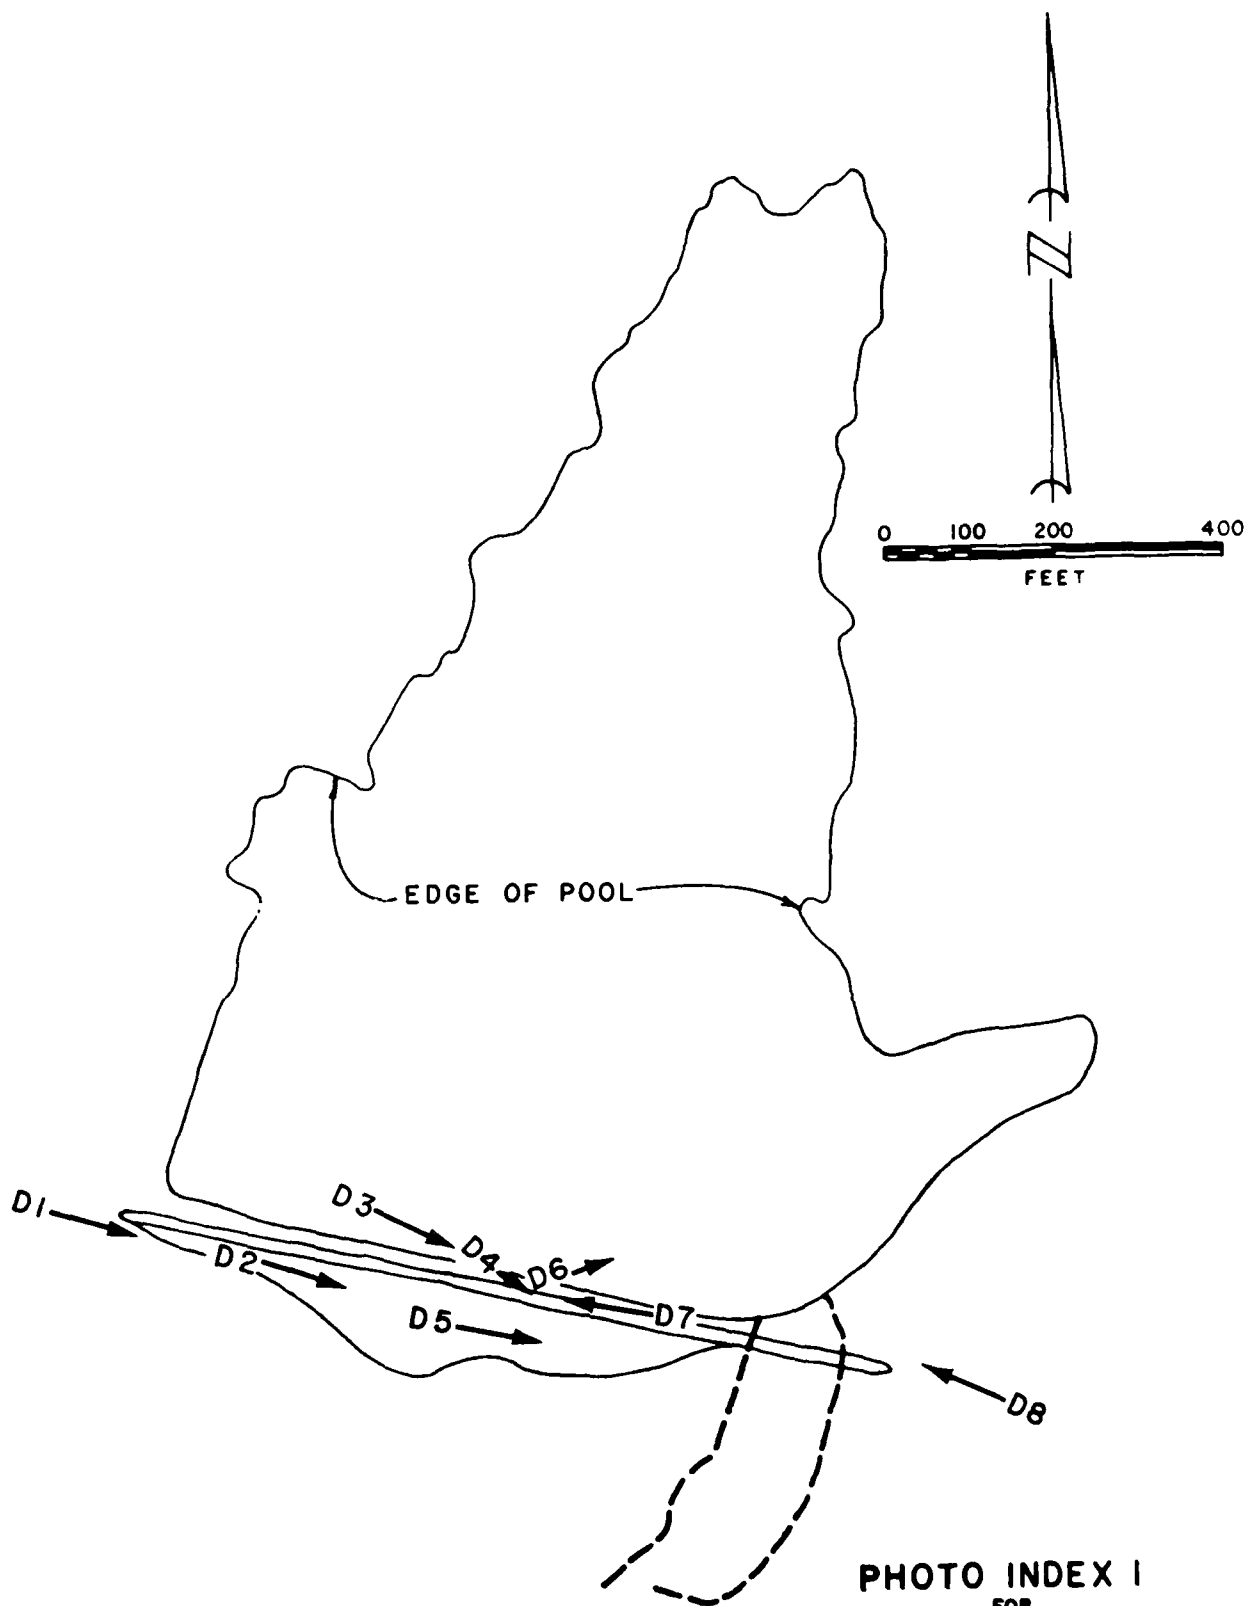
PHOTO INDEX I  
FOR  
DAM

b. Dam This is an earth dam. Both when inspected and during field surveys, the water surface in the reservoir was lower than the principal spillway, resulting from a decision by the owner to lower the lake to reduce probability of recurrence of dangerous slides. A report was available (see Plate 4) from the Missouri Geological Survey which summarized observations and recommendations from a site visit on 24 May 1978. A slide occurred earlier in 1978 in the vicinity of Stations 4+ to 5+. The visible earth tones of the maintenance show the location (D-8).
